**Flood Control Project Maintenance  
Levee Inspections****LMA District Cover Sheet****Spring 2016 Levee Inspection Results****Reclamation District No. 0544 Upper Roberts Island**

**Spring 2016 Levee Inspection Results**

**Reclamation District No. 0544 Upper Roberts Island**

Waterway			Bank	Unit Miles
Unit No. 01 San Joaquin River			Left	6.05
	Spring (March - May)	Summer (June - August)	(September - November) Fall	Winter (December - February)
Unit Maintenance Rating (Fall Only)				
Date of Inspection	4/19/2016 - 4/19/2016			
DWR Inspector	Richard Willoughby			
Accompanied By

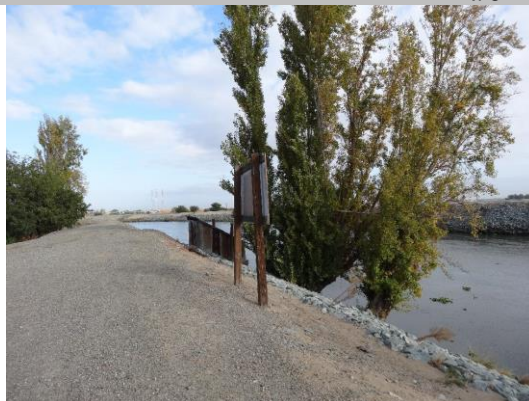
Photo 1 of 2 : UCIP\_SP\_2016\_41906\_41713.jpg

WS view: a signboard indicating a gasoline on levee shoulder.

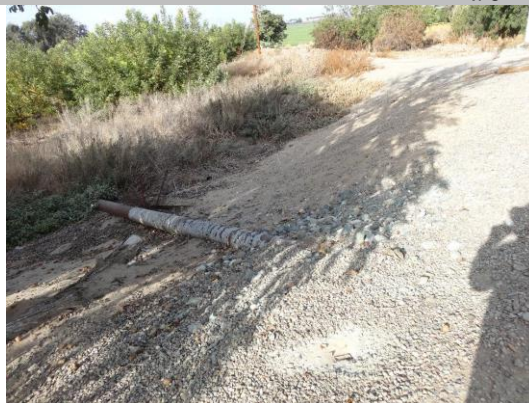
Photo 1 of 2 : UCIP\_SP\_2016\_23851\_41728.jpg

LM Start	0.01	Rating **	M	Issue No.	168
LM End	0.01	Issue Type +	En	Location *	N/A
Category	Supplemental			GPS Latitude/Longitude	
				Start	End
Item	DWR UCIP Field Study			37.870296 °	37.870296 °
				-121.329826 °	-121.329826 °
DWR ID					
Comment Code					
Inspector Comment					
FS_ID:23851 DS_ID:24713 EP_NO: N/A Repair Type: Non-Urgent Crossing Status: Found UCIP Comments: Appears abandoned.May need proper abandonment.Pipe exposed on landside slope. FIELD_STRUCT_DESC: A 12-inch steel pipe through the levee, 2 feet below levee crown. Appears abandoned. Only visible on landside slope. No pipe and other features visible on waterside. FS Date: 10/29/2013

LS view: exposed 12-inch steel pipe on levee slope. Appears abandoned.

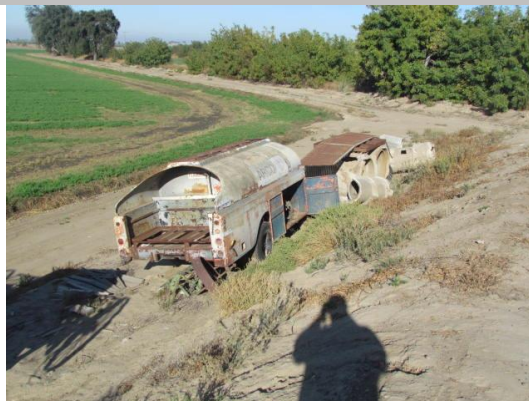
Photo 1 of 5 : SP\_2016\_RD0544\_108\_4\_20160404\_00004.jpg

Looking west at equipment stored at landward toe fall 2015

LM Start	0.06	Rating **	M	Issue No.	4 (cont)	
LM End	0.19	Issue Type +	Ma	Location *	LS	
Category	Earthen Levee			GPS Latitude/Longitude		
				Start		End
Item	Encroachments			37.869606 °	37.868163 °	
				-121.329571 °	-121.328132 °	
DWR ID	DWR_RD0544_01_s_2012_4					
Comment Code						
EQ : Equipment						
Inspector Comment						
Farm equipment and supplies stored at landward toe.

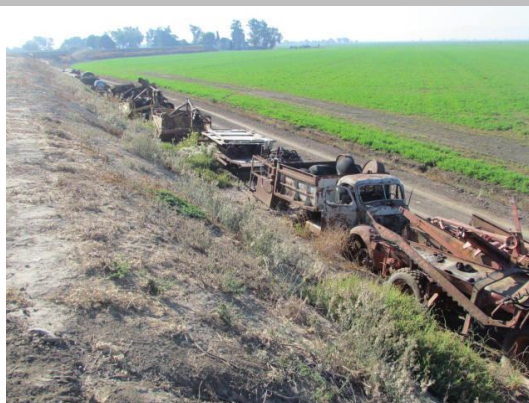
Photo 2 of 5 : SP\_2016\_RD0544\_108\_4\_20160404\_00005.jpg

Looking southwest at equipment stored at landward toe fall 2015.

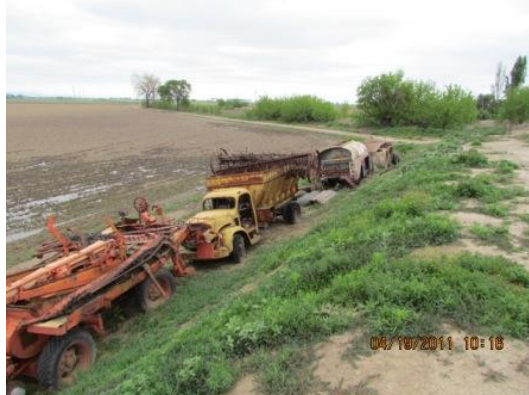
Photo 4 of 5 : SP\_2016\_RD0544\_108\_4\_20160404\_00007.jpg

Looking north at equipment along landside toe.

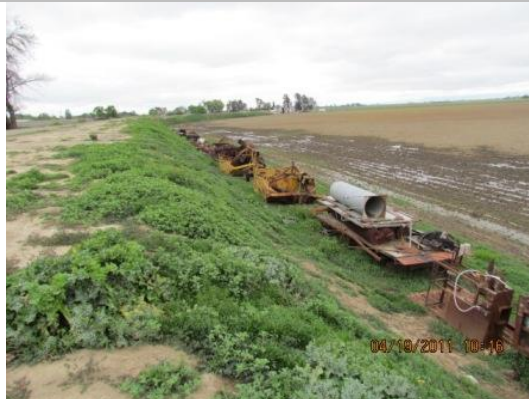
Photo 5 of 5 : SP\_2016\_RD0544\_108\_4\_20160404\_00008.jpg

Looking south at equipment along landside toe.

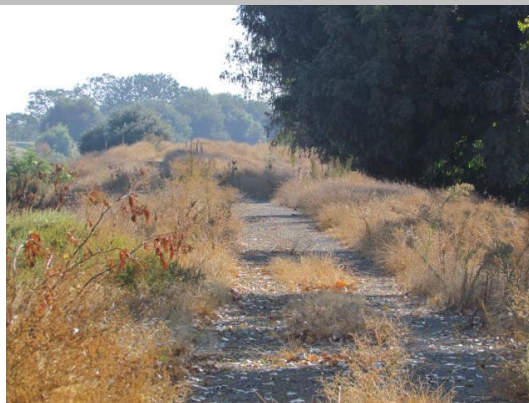
Photo 2 of 2 : SP\_2016\_RD0544\_108\_3\_20160404\_00003.jpg

LM Start	0.48	Rating **	A/W	Issue No.	3 (cont)	
LM End	0.67	Issue Type +	Ma	Location *	WS	
Category	Earthen Levee			GPS Latitude/Longitude		
				Start		End
Item	Vegetation			37.864578 °	37.863753 °	
				-121.326210 °	-121.322835 °	
DWR ID	DWR_RD0544_01_s_2012_3					
Comment Code						
V2 : Remove the wild growth other than native grasses from the levee slopes.						
Inspector Comment						
Issue has been corrected, but should be monitored.

Looking south at overgrown on landward and waterward slopes.

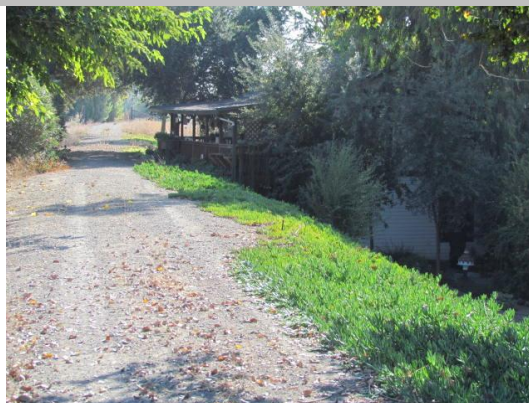
Photo 2 of 2 : SP\_2016\_RD0544\_108\_9\_20160404\_00012.jpg

Looking south at landscaping on landward slope.

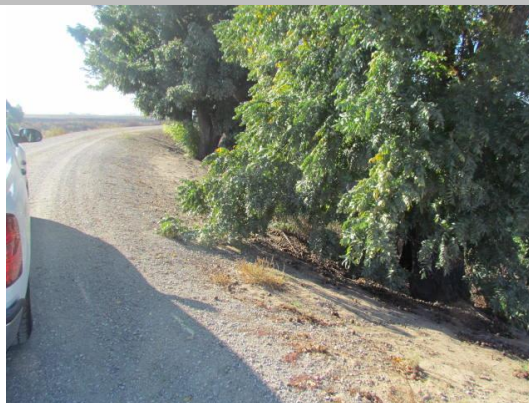
Photo 1 of 2 : SP\_2016\_RD0544\_108\_39\_20160404\_00031.jpg

Looking southwest at untrimmed tree at landward slope and toe fall 2015.

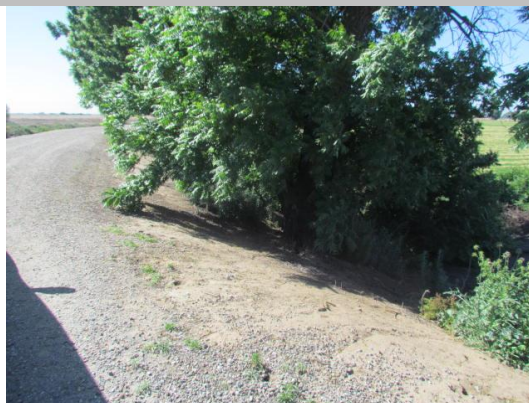
Photo 2 of 2 : SP\_2016\_RD0544\_108\_39\_20160404\_00032.jpg

Looking southwest at untrimmed tree at landward slope and toe spring 2015

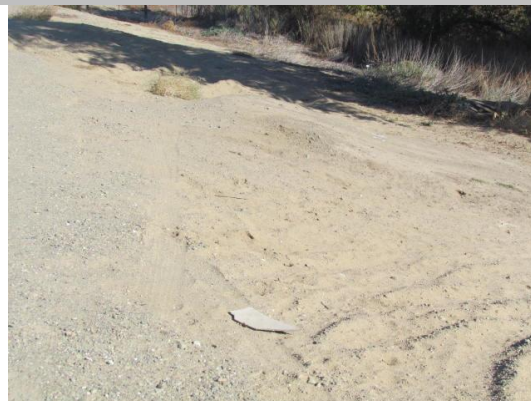
Photo 3 of 3 : SP\_2016\_RD0544\_108\_119\_20160404\_00075.jpg

LM Start	1.50	Rating **	U	Issue No.	119 (cont)	
LM End	1.51	Issue Type +	Ma	Location *	WS	
Category	Earthen Levee			GPS Latitude/Longitude		
				Start		End
Item	Slope Stability			37.854844 °		37.854564 °
				-121.321090 °		-121.321031 °
DWR ID	DWR_RD0544_01_f_2015_119					
Comment Code						
S3 : Repair the levee slope damaged by vehicle traffic and prevent access where possible.						
Inspector Comment						
Damaged levee slope due to fishermen using slope as a ramp.

Looking southeast at damaged waterward slope fall 2015

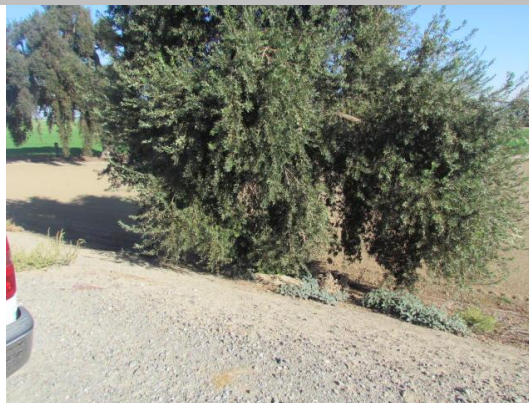
Photo 1 of 1 : SP\_2016\_RD0544\_108\_96\_20160404\_00059.jpg

LM Start	1.64	Rating **	U	Issue No.	96
LM End	1.64	Issue Type +	Ma	Location *	LS
Category	Earthen Levee			GPS Latitude/Longitude	
				Start	End
Item	Trim / Thin Trees			37.854681 °	37.854681 °
				-121.322493 °	-121.322493 °
DWR ID	DWR_RD0544_01_f_2014_96				
Comment Code					
T2 : Thin trees to allow visibility of the ground and room to flood fight.					
Inspector Comment

Looking at untrimmed tree on landward slope and toe.

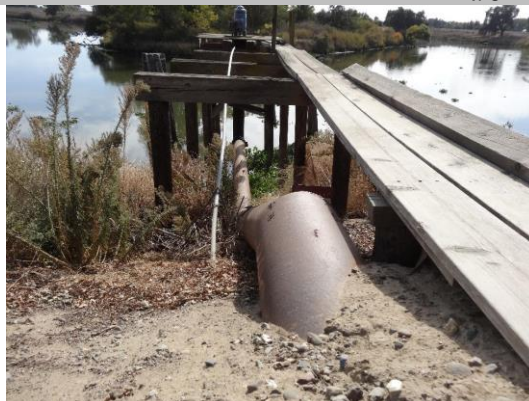
Photo 1 of 2 : UCIP\_SP\_2016\_43023\_41786.jpg

WS view: pipe, conduit, walkway, and pump on levee slope.

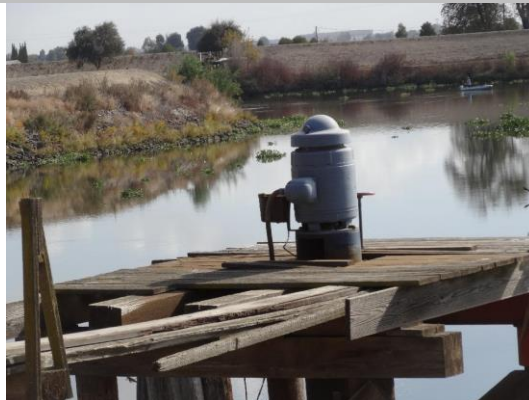
Photo 2 of 2 : UCIP\_SP\_2016\_43023\_41785.jpg

WS view: pump on wooden pile structure in the stream.

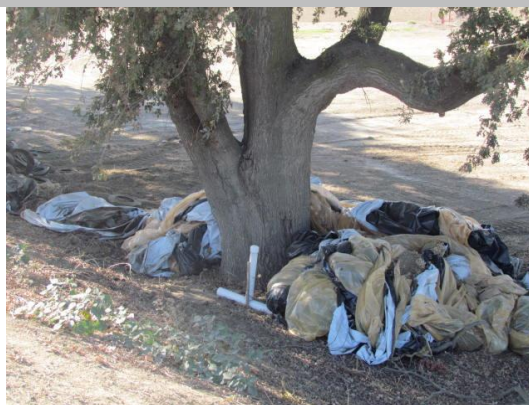
Photo 1 of 2 : SP\_2016\_RD0544\_108\_64\_20160404\_00044.jpg

LM Start	1.91	Rating **	U	Issue No.	64
LM End	1.93	Issue Type +	En	Location *	LS
Category	Earthen Levee			GPS Latitude/Longitude	
				Start	End
Item	Encroachments			37.852006 °	37.851746 °
				-121.323554 °	-121.323328 °
DWR ID	DWR_RD0544_01_f_2015_64				
Comment Code					
GA : Garbage					
Inspector Comment					
Plastic sheeting and rubber tires stored at landward toe.

Looking west at plastic sheeting stored at landward toe.

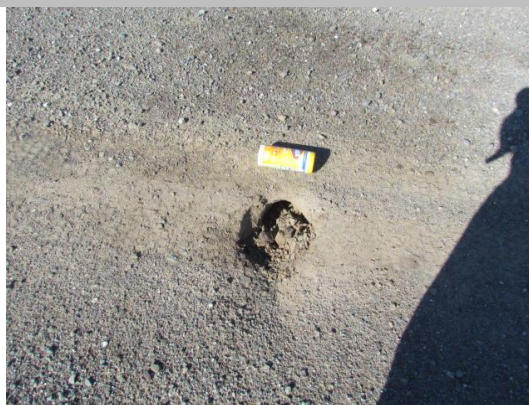
Photo 1 of 2 : SP\_2016\_RD0544\_108\_90\_20160404\_00052.jpg

LM Start	2.01	Rating **	A/W	Issue No.	90
LM End	2.01	Issue Type +	Ma	Location *	CR
Category	Earthen Levee			GPS Latitude/Longitude	
				Start	End
Item	Animal Control			37.850825 °	37.850825 °
				-121.322475 °	-121.322475 °
DWR ID	DWR_RD0544_01_s_2014_90				
Comment Code					
A3 : No rodents visible, but rodent burrows visible; need to backfill and compact or grout burrows.					
Inspector Comment					
LMA grouted rodent hole on levee crown.

Looking at rodent hole on levee crown.

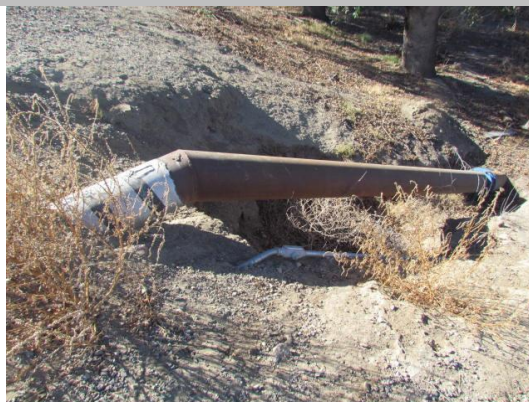
Photo 1 of 3 : SP\_2016\_RD0544\_108\_23\_20160404\_00017.jpg

LM Start	2.26	Rating **	U	Issue No.	23
LM End	2.26	Issue Type +	Ma	Location *	LS
Category	Earthen Levee			GPS Latitude/Longitude	
				Start	End
Item	Erosion / Bank Caving			37.848155 °	37.848155 °
				-121.324897 °	-121.324897 °
DWR ID	DWR_RD0544_01_s_2012_23				
Comment Code					
E2 : Schedule repair of erosion site prior to the next inspection.					
Inspector Comment					
Caving/erosion around irrigation pipe on landside slope.

Looking south at erosion around irrigation pipe on landside slope. (Fall 2014)

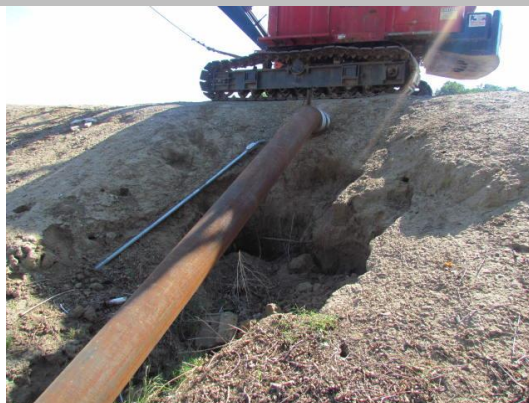
Photo 3 of 3 : SP\_2016\_RD0544\_108\_23\_20160404\_00019.jpg

Looking east at erosion under irrigation pipe on landside slope.

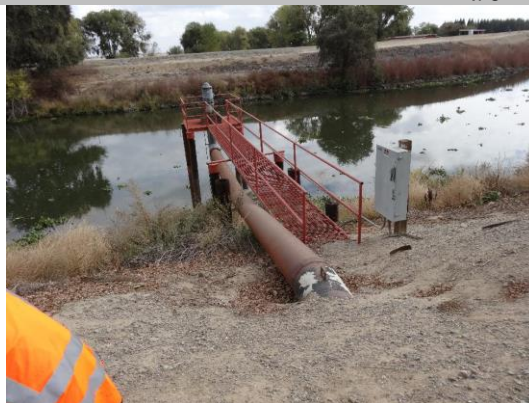
Photo 1 of 2 : UCIP\_SP\_2016\_23946\_42017.jpg

WS view: exposed pipe, walkway to pump, pump on pile structure in the stream.

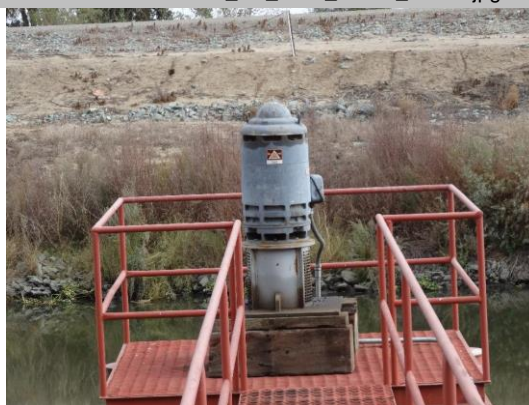
Photo 2 of 2 : UCIP\_SP\_2016\_23946\_42016.jpg

WS view: walkway to pump, pump on pile structure in the stream.

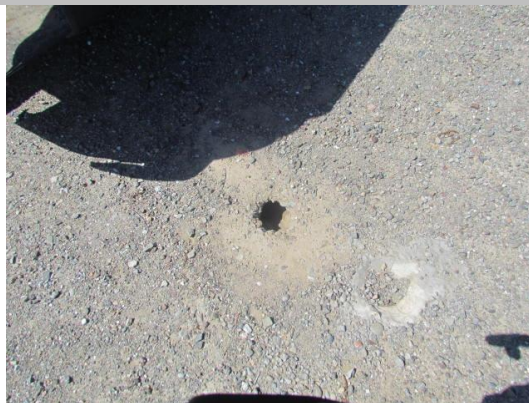
Photo 2 of 2 : SP\_2016\_RD0544\_108\_34\_20160404\_00026.jpg

LM Start	2.32	Rating **	M	Issue No.	34 (cont)	
LM End	2.36	Issue Type +	Ma	Location *	LS	
Category	Earthen Levee			GPS Latitude/Longitude		
				Start		End
Item	Animal Control			37.847292 °		37.846743 °
				-121.324662 °		-121.324336 °
DWR ID	DWR_RD0544_01_s_2012_34					
Comment Code						
A1 : Exterminate rodents and backfill and compact or grout burrows.						
Inspector Comment						
Several rodent hole within this reach.

Looking at rodent hole on levee crown.

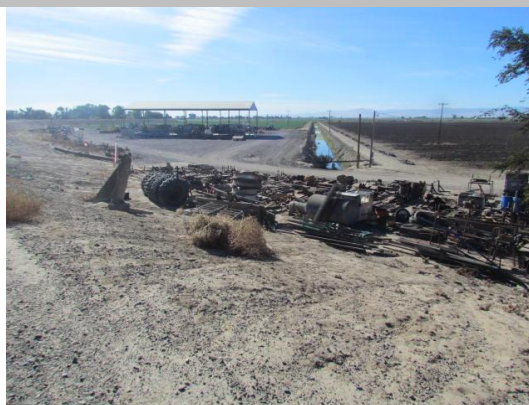
Photo 1 of 1 : SP\_2016\_RD0544\_108\_68\_20160404\_00047.jpg

LM Start	2.40	Rating **	M	Issue No.	68
LM End	2.40	Issue Type +	En	Location *	LS
Category	Earthen Levee			GPS Latitude/Longitude	
				Start	End
Item	Encroachments			37.846315 °	37.846315 °
				-121.323875 °	-121.323875 °
DWR ID	DWR_RD0544_01_s_2013_68				
Comment Code					
EQ : Equipment					
Inspector Comment					
Equipment on landward toe.

Looking west at equipment at landward toe.

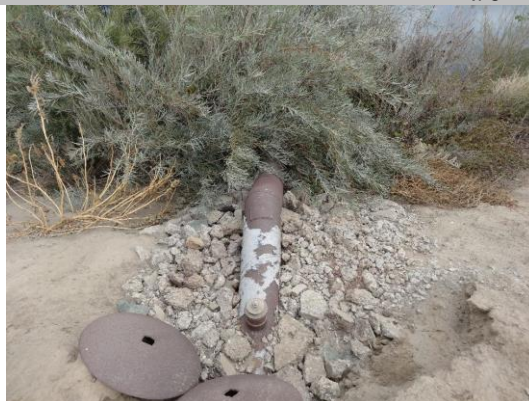
Photo 1 of 2 : UCIP\_SP\_2016\_46671\_44836.jpg

WS view: exposed steel pipe and siphon breaker on levee slope.

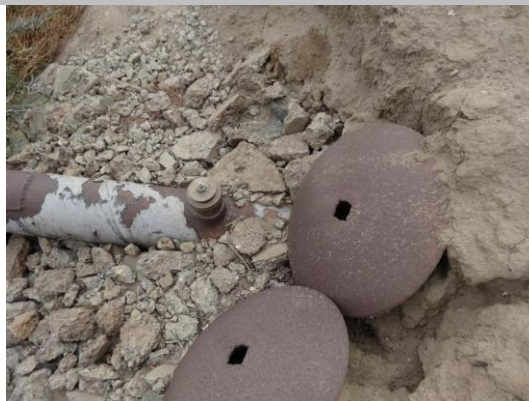
Photo 2 of 2 : UCIP\_SP\_2016\_46671\_44835.jpg

WS view: exposed steel pipe and soil erosion around siphon breaker on levee slope.

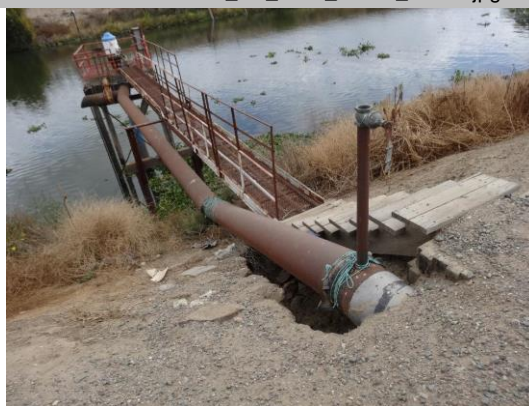
Photo 1 of 2 : UCIP\_SP\_2016\_24889\_44839.jpg

LM Start	2.57	Rating **	U	Issue No.	165
LM End	2.57	Issue Type +	En	Location *	LS
Category	Supplemental			GPS Latitude/Longitude	
				Start	End
Item	DWR UCIP Field Study			37.844386 °	37.844386 °
				-121.321894 °	-121.321894 °
DWR ID					
Comment Code					
Inspector Comment					
FS_ID:24889					
DS_ID:22655					
EP_NO: N/A					
Repair Type: Urgent					
Crossing Status: Found					
UCIP Comments: Siphon breaker on the landward shoulder not found.Service pole on landside.Huge erosion on landside and waterside of the levee due to the pipe leakage.					
FIELD_STRUCT_DESC: 12-inch steel pipe through the levee, 2.0 feet below the crown; pump mounted on pile structure in the stream. Steel walkway to the pump. Air relief valve on the waterside shoulder. Concrete distribution box at the toe of the landward slope. O&M Manual SJR 007, April 1964.					
FS Date: 10/29/2013

WS view: exposed pipe, walkway to pump, and pump on pile structure in the stream.

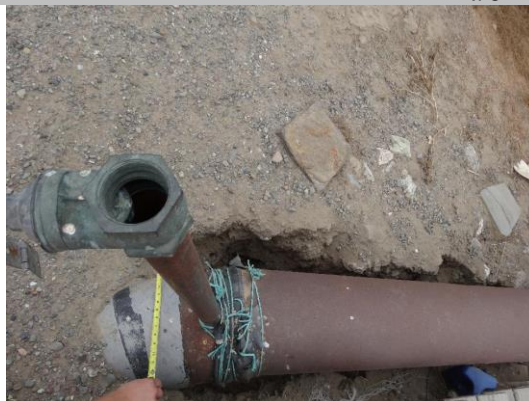
Photo 2 of 2 : UCIP\_SP\_2016\_24889\_44838.jpg

Item	DWR UCIP Field Study			37.844386 °		37.844386 °
				-121.321894 °		-121.321894 °
DWR ID						
Comment Code						
Inspector Comment						
FS_ID:24889						
DS_ID:22655						
EP_NO: N/A						
Repair Type: Urgent						
Crossing Status: Found						
UCIP Comments: Siphon breaker on the landward shoulder not found.Service pole on landside.Huge erosion on landside and waterside of the levee due to the pipe leakage.						
FIELD_STRUCT_DESC: 12-inch steel pipe through the levee, 2.0 feet below the crown; pump mounted on pile structure in the stream. Steel walkway to the pump. Air relief valve on the waterside shoulder.						
Concrete distribution box at the toe of the landward slope. O&M Manual SJR 007, April 1964.						
FS Date: 10/29/2013

WS view: exposed pipe, air relief valve, and huge erosion on levee slope.

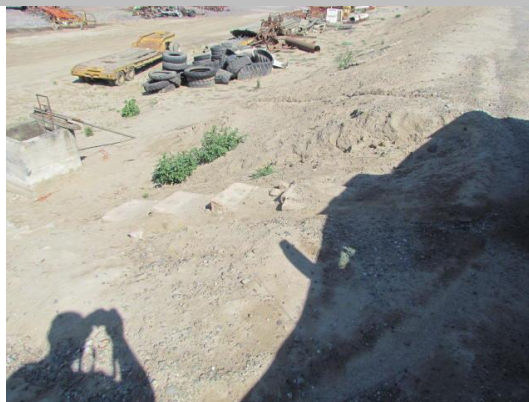
Photo 1 of 2 : SP\_2016\_RD0544\_108\_60\_20160404\_00041.jpg

LM Start	2.57	Rating **	M	Issue No.	60
LM End	2.57	Issue Type +	Ma	Location *	LS
Category	Earthen Levee			GPS Latitude/Longitude	
				Start	End
Item	Slope Stability			37.844337 °	37.844337 °
				-121.321853 °	-121.321853 °
DWR ID	DWR_RD0544_01_s_2012_60				
Comment Code					
S2 : Repair the levee slope damaged by foot traffic and prevent access where possible.					
Inspector Comment					
Finger erosion on landward slope.

Looking north at slope damage on landside slope.

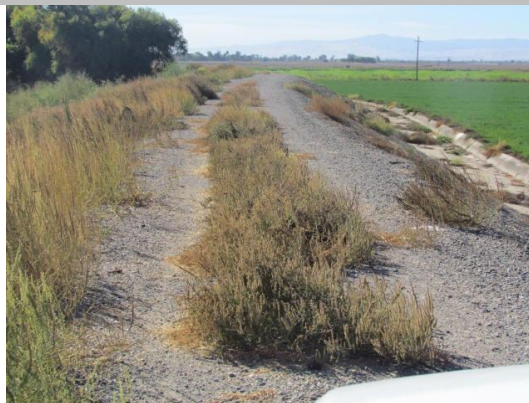
Photo 1 of 1 : SP\_2016\_RD0544\_108\_100\_20160404\_00061.jpg

LM Start	2.65	Rating **	M	Issue No.	100
LM End	2.94	Issue Type +	Ma	Location *	CR
Category	Earthen Levee			GPS Latitude/Longitude	
				Start	End
Item	Vegetation			37.843262 °	37.840656 °
				-121.321666 °	-121.318590 °
DWR ID	DWR_RD0544_01_f_2014_100				
Comment Code					
V2 : Remove the wild growth other than native grasses from the levee slopes.					
Inspector Comment

Looking south at vegetation on levee crown.

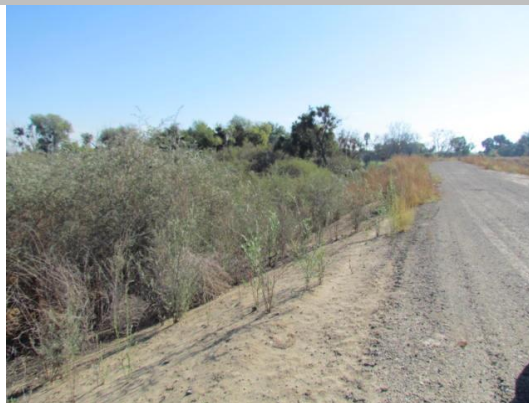
Photo 1 of 1 : SP\_2016\_RD0544\_108\_106\_20160404\_00064.jpg

LM Start	2.89	Rating **	U	Issue No.	106
LM End	3.16	Issue Type +	Ma	Location *	WS
Category	Earthen Levee			GPS Latitude/Longitude	
				Start	End
Item	Vegetation			37.840952 °	37.837588 °
				-121.319327 °	-121.317540 °
DWR ID	DWR_RD0544_01_s _ 2015_106				
Comment Code					
V2 : Remove the wild growth other than native grasses from the levee slopes.					
Inspector Comment					
Dense willows and vegetation waterward slope.

Looking southeast at dense willows (veg) on waterward slope and toe fall 2015.

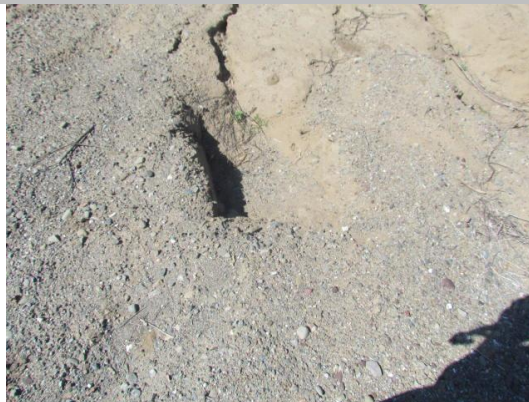
Photo 1 of 2 : SP\_2016\_RD0544\_108\_107\_20160404\_00065.jpg

LM Start	2.95	Rating **	M	Issue No.	107
LM End	2.96	Issue Type +	Ma	Location *	LS
Category	Earthen Levee			GPS Latitude/Longitude	
				Start	End
Item	Erosion / Bank Caving			37.840560 °	37.840467 °
				-121.318463 °	-121.318367 °
DWR ID	DWR_RD0544_01_s _ 2015_107				
Comment Code					
E1 : Note and monitor erosion site.					
Inspector Comment					
Several depressions on landward slope within this reach.

Looking south at depression on landward slope.

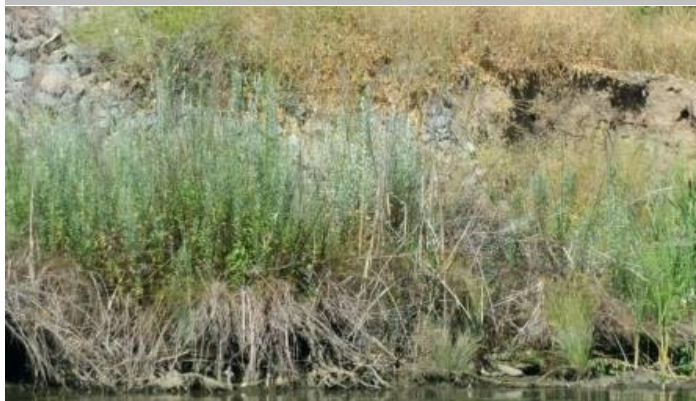
Photo 1 of 2 : SP\_2016\_RD0544\_108\_38\_20160404\_00029.jpg

LM Start	2.95	Rating **	U	Issue No.	38
LM End	2.95	Issue Type +	Ma	Location *	WS
Category	Supplemental			GPS Latitude/Longitude	
				Start	End
Item	DWR Erosion Survey			37.840697 °	37.840697 °
				-121.318252 °	-121.318252 °
DWR ID	DWR_RD0544_01_s_2016_38				
Comment Code					
Inspector Comment					
06/24/2015: No significant change observed.					
6/19/2014: No significant change observed.					
08/13/2013: Pump has been removed. A larger pocket erosion has been found at the erosion site.					
08/07/2012: The erosion is immediately upstream of a river bend.					
Dense vegetation is visible at the erosion site. [2015 Site ID:RD0544U01RM49.67]

Close view of the site.

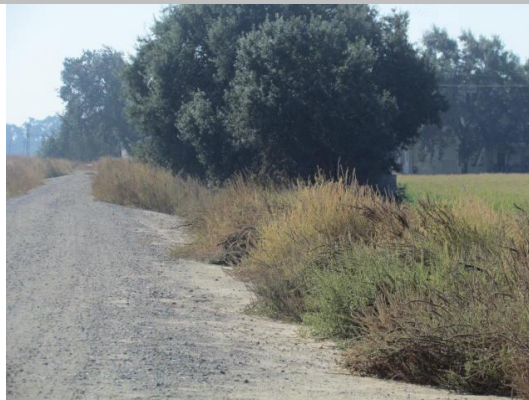
Photo 1 of 1 : SP\_2016\_RD0544\_108\_47\_20160404\_00037.jpg

LM Start	2.95	Rating **	U	Issue No.	47
LM End	3.19	Issue Type +	Ma	Location *	LS
Category	Earthen Levee			GPS Latitude/Longitude	
				Start	End
Item	Vegetation			37.840485 °	37.837225 °
				-121.318390 °	-121.317408 °
DWR ID	DWR_RD0544_01_s _ 2012_47				
Comment Code					
V2 : Remove the wild growth other than native grasses from the levee slopes.					
Inspector Comment

Looking south at dense veg on landward slope fall 2015.

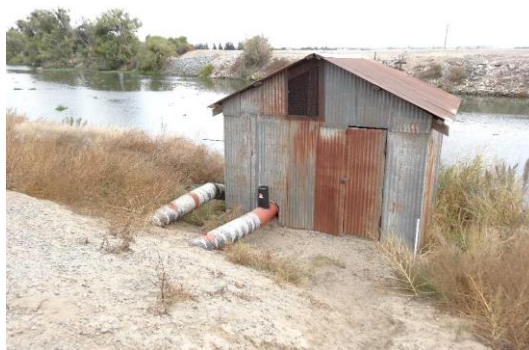
Photo 1 of 2 : UCIP\_SP\_2016\_43025\_42207.jpg

FS\_ID:43025  
DS\_ID:22656  
EP\_NO: N/A  
Repair Type: Urgent  
Crossing Status: Found  
UCIP Comments: - huge levee slope erosion on landside. Walkway to distro box on LS toe in poor structural condition.- 1-inch electric conduit, power pole on landside.- not clear whether this is a irrigation or drainage pipe.  
FIELD\_STRUCT\_DESC: 1 of 2: Two 14-inch steel pipes through the levee, 8.0 feet below the crown. Slide gates in 6-foot by 6-foot concrete distribution box at the toe of the landward slope. O&M Manual SJR 007, April 1964.  
FS Date: 10/29/2013

WS view: exposed steel pipes, levee slope, and pumphouse for 2nd pipe.

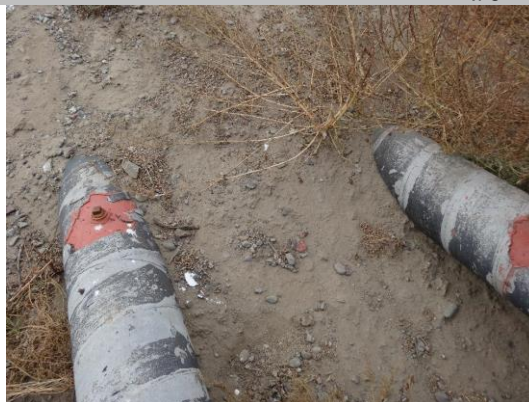
Photo 2 of 2 : UCIP\_SP\_2016\_43025\_42206.jpg

WS view: exposed steel pipes on levee slope.

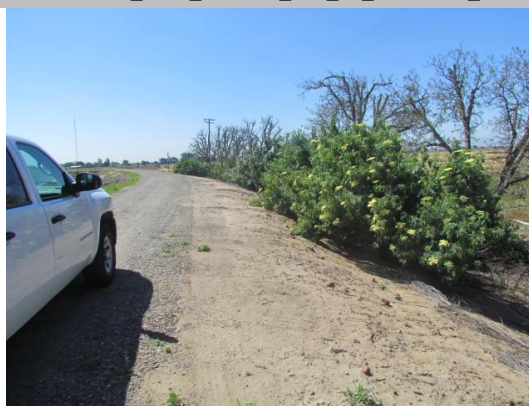
Photo 1 of 1 : SP\_2016\_RD0544\_108\_49\_20160404\_00038.jpg

LM Start	3.22	Rating **	M	Issue No.	49
LM End	3.84	Issue Type +	Ma	Location *	WS
Category	Earthen Levee			GPS Latitude/Longitude	
				Start	End
Item	Vegetation			37.836763 °	37.829195 °
				-121.317307 °	-121.311918 °
DWR ID	DWR_RD0544_01_s_2012_49				
Comment Code					
V2 : Remove the wild growth other than native grasses from the levee slopes.					
Inspector Comment

Looking southwest at untrimmed trees at landward toe.

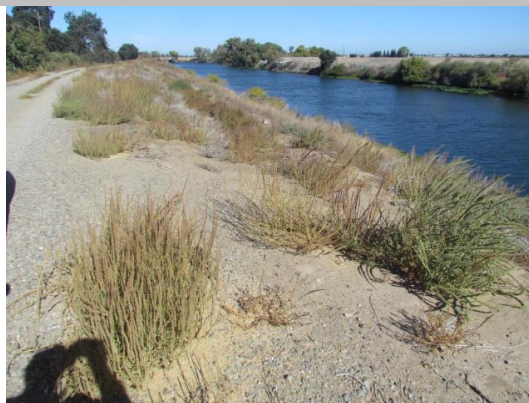
Photo 1 of 1 : SP\_2016\_RD0544\_108\_37\_20160404\_00028.jpg

LM Start	3.28	Rating **	M	Issue No.	37
LM End	3.28	Issue Type +	En	Location *	WS
Category	Earthen Levee			GPS Latitude/Longitude	
				Start	End
Item	Encroachments			37.835951 °	37.835951 °
				-121.317062 °	-121.317062 °
DWR ID	DWR_RD0544_01_s_2012_37				
Comment Code					
RA : Ramp					
Inspector Comment					
Landowner has cut new ramp on waterside slope.

Looking north at ramp on waterward slope.

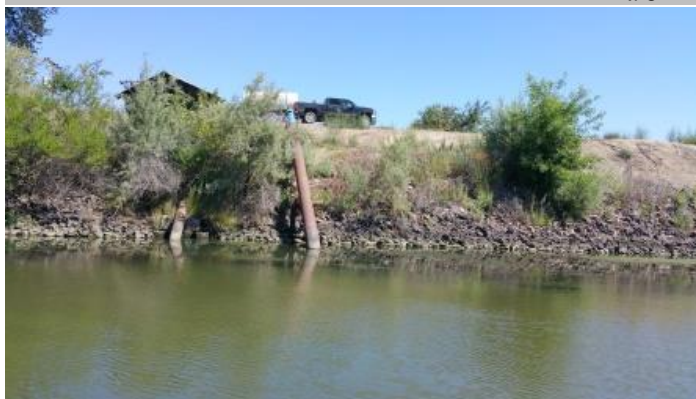
Photo 1 of 2 : SP\_2016\_RD0544\_108\_46\_20160404\_00035.jpg

LM Start	4.23	Rating **	M	Issue No.	46
LM End	4.24	Issue Type +	Ma	Location *	WS
Category	Supplemental			GPS Latitude/Longitude	
				Start	End
Item	DWR Erosion Survey			37.825248 °	37.825248 °
				-121.313856 °	-121.313856 °
DWR ID	DWR_RD0544_01_s _ 2016_46				
Comment Code					
Inspector Comment					
06/24/2015: No significant change observed.					
06/19/2014: No significant change observed.					
08/13/2013: The erosion has been caused by irrigation pipe. [2015 Site ID:RD0544U01RM51.04]

Front view of the site.

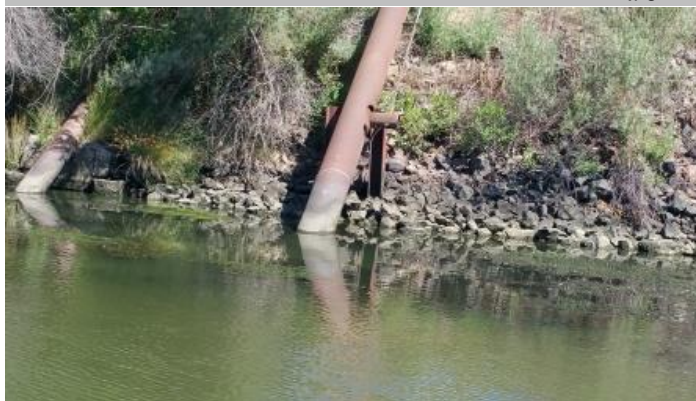
Photo 2 of 2 : SP\_2016\_RD0544\_108\_46\_20160404\_00036.jpg

Close view of the site.

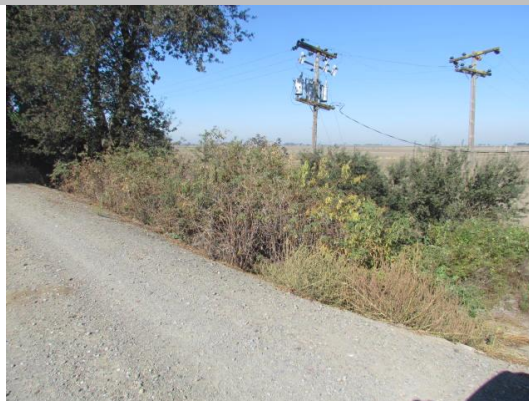
Photo 1 of 1 : SP\_2016\_RD0544\_108\_57\_20160404\_00040.jpg

LM Start	4.24	Rating **	U	Issue No.	57
LM End	4.49	Issue Type +	Ma	Location *	LS
Category	Earthen Levee			GPS Latitude/Longitude	
				Start	End
Item	Vegetation			37.825517 °	37.822955 °
				-121.314160 °	-121.316835 °
DWR ID	DWR_RD0544_01_s _ 2012_57				
Comment Code					
V4 : Elderberries are blocking visibility and flood fight capability.					
Inspector Comment					
Dense elderberry on landward slope and toe.

Looking southwest at dense elderberries on landward slope fall 2015.

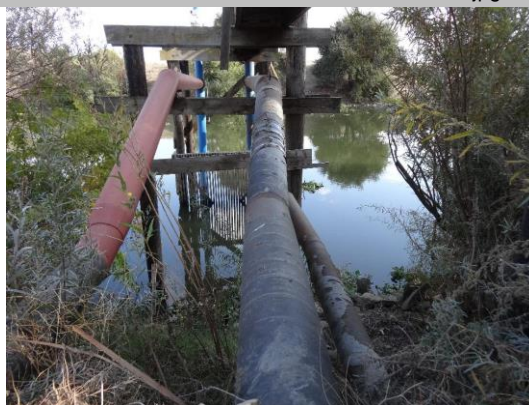
Photo 1 of 2 : UCIP\_SP\_2016\_24893\_44858.jpg

Comment Code					
Inspector Comment					
FS_ID:24893 DS_ID:22660 EP_NO: 11536 Repair Type: Non-Urgent Crossing Status: Found UCIP Comments: - siphon breaker was removed from CMP riser on landside shoulder. Needs replacement.- some details about existing pipes available in new Application no. 18903.- electric control box on landside and conduit on waterside. FIELD_STRUCT_DESC: 1 of 3: 12-inch diameter steel irrigation pipe, 16-inch diameter steel irrigation pipe and an 8-inch diameter steel discharge pipe through the levee, 3.0 feet below the crown. Pump on pump platform in channel with a walkway to the waterward slope. Siphon breaker in CMP riser and concrete standpipe on landside. (App. No. 11536-Phelps) O&M Manual SJR 007, April 1964. FS Date: 10/29/2013

WS view: pipes, pumps, walkway to pump, and pile structure in the stream.

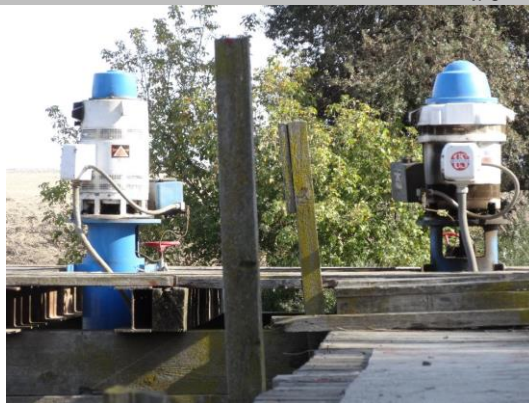
Photo 2 of 2 : UCIP\_SP\_2016\_24893\_44857.jpg

Item	DWR UCIP Field Study			37.825071 °	37.825071 °	
				-121.314932 °	-121.314932 °	
DWR ID						
Comment Code						
Inspector Comment						
FS_ID:24893 DS_ID:22660 EP_NO: 11536 Repair Type: Non-Urgent Crossing Status: Found UCIP Comments: - siphon breaker was removed from CMP riser on landside shoulder. Needs replacement.- some details about existing pipes available in new Application no. 18903.- electric control box on landside and conduit on waterside. FIELD_STRUCT_DESC: 1 of 3: 12-inch diameter steel irrigation pipe, 16-inch diameter steel irrigation pipe and an 8-inch diameter steel discharge pipe through the levee, 3.0 feet below the crown. Pump on pump platform in channel with a walkway to the waterward slope. Siphon breaker in CMP riser and concrete standpipe on landside. (App. No. 11536-Phelps) O&M Manual SJR 007, April 1964. FS Date: 10/29/2013

WS view: pumps, walkway to pump, and pile structure in the stream.

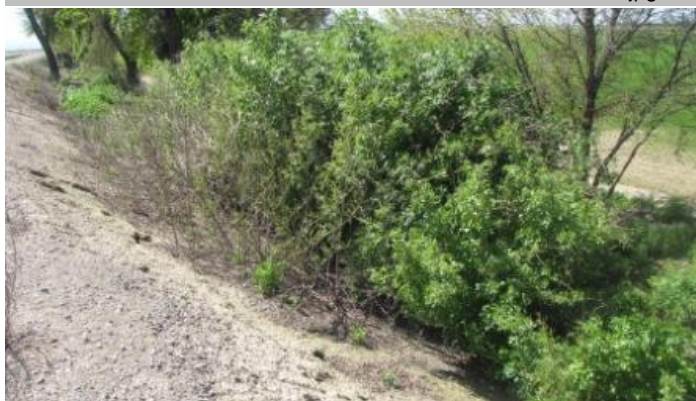
Photo 1 of 1 : SP\_2016\_RD0544\_108\_41\_20160404\_00033.jpg

LM Start	4.49	Rating **	U	Issue No.	41
LM End	4.49	Issue Type +	Ma	Location *	LS
Category	Earthen Levee			GPS Latitude/Longitude	
				Start	End
Item	Vegetation			37.822934 °	37.822934 °
				-121.316870 °	-121.316870 °
DWR ID	DWR_RD0544_01_s_2012_41				
Comment Code					
V4 : Elderberries are blocking visibility and flood fight capability.					
Inspector Comment

Looking south at elderberries on landside slope and toe.

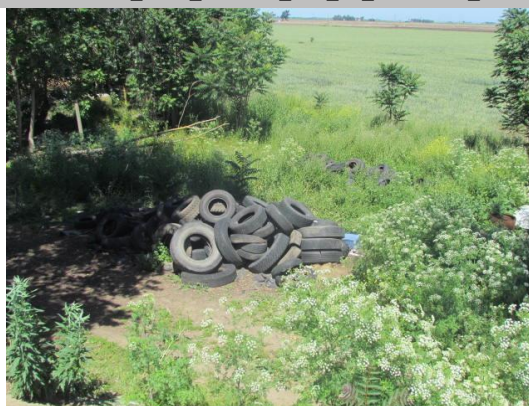
Photo 1 of 1 : SP\_2016\_RD0544\_108\_27\_20160404\_00020.jpg

LM Start	4.68	Rating **	U	Issue No.	27
LM End	4.68	Issue Type +	En	Location *	LS
Category	Earthen Levee			GPS Latitude/Longitude	
				Start	End
Item	Encroachments			37.821847 °	37.821847 °
				-121.320027 °	-121.320027 °
DWR ID	DWR_RD0544_01_s_2012_27				
Comment Code					
GA : Garbage					
Inspector Comment					
Tires stock pile on landward toe.

Looking west at tires stock pile on landward berm.

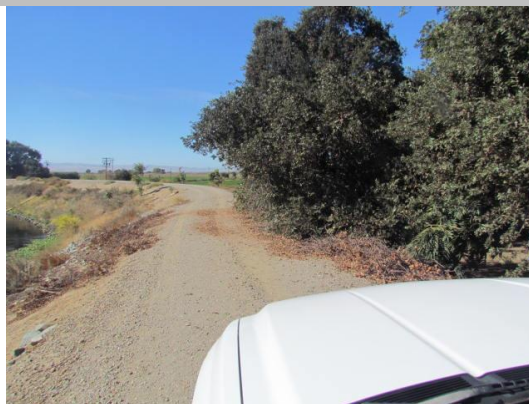
Photo 1 of 1 : SP\_2016\_RD0544\_108\_105\_20160404\_00063.jpg

LM Start	4.69	Rating **	U	Issue No.	105
LM End	4.69	Issue Type +	Ma	Location *	LS
Category	Earthen Levee			GPS Latitude/Longitude	
				Start	End
Item	Trim / Thin Trees			37.821775 °	37.821775 °
				-121.320203 °	-121.320203 °
DWR ID	DWR_RD0544_01_f_2014_105				
Comment Code					
T2 : Thin trees to allow visibility of the ground and room to flood fight.					
Inspector Comment					
Tree has overgrown onto levee crown.

Looking south at overgrown tree on landward shoulder.

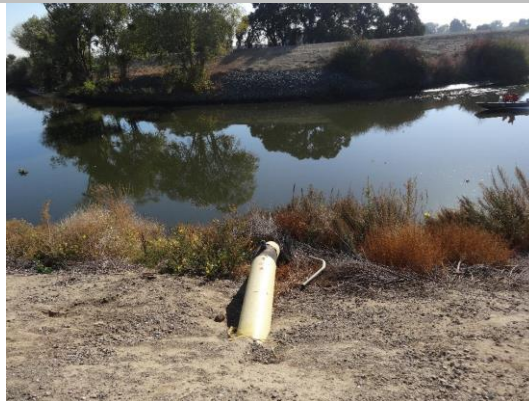
Photo 1 of 2 : UCIP\_SP\_2016\_24894\_44864.jpg

LM Start	4.75	Rating **	U	Issue No.	167
LM End	4.75	Issue Type +	En	Location *	LS
Category	Supplemental			GPS Latitude/Longitude	
				Start	End
Item	DWR UCIP Field Study			37.821153 °	37.821153 °
				-121.320995 °	-121.320995 °
DWR ID					
Comment Code					
Inspector Comment					
FS_ID:24894					
DS_ID:22661					
EP_NO: N/A					
Repair Type: Urgent					
Crossing Status: Found					
UCIP Comments: - huge erosion on landside slope due to leaky pipe.- small depression on waterside slope.					
FIELD_STRUCT_DESC: 12-inch diameter steel pipe through the levee, 4.4 feet below crown. Pump house on the landward slope. Pressure relief valve on the landside slope. Concrete distribution box at toe of landward slope. O&M Manual SJR 007, April 1964.					
FS Date: 10/31/2013

WS view: exposed steel pipe on levee slope.

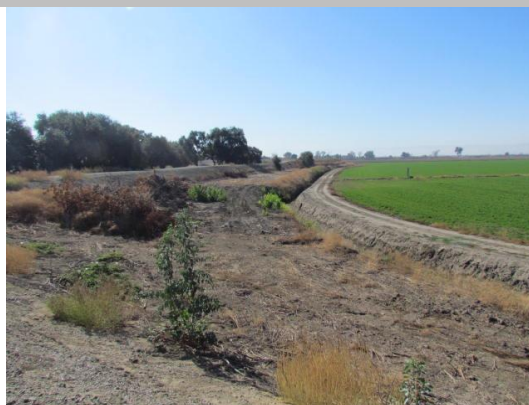
Photo 1 of 2 : SP\_2016\_RD0544\_108\_33\_20160404\_00023.jpg

LM Start	4.95	Rating **	A/W	Issue No.	33
LM End	5.26	Issue Type +	Ma	Location *	LS
Category	Earthen Levee			GPS Latitude/Longitude	
				Start	End
Item	Vegetation			37.818718 °	37.814662 °
				-121.319508 °	-121.320302 °
DWR ID	DWR_RD0544_01_s_2012_33				
Comment Code					
V2 : Remove the wild growth other than native grasses from the levee slopes.					
Inspector Comment					
Vegetation has been sprayed, and it should be monitored.

Looking southwest at cleared landward slope and berm fall 2015.

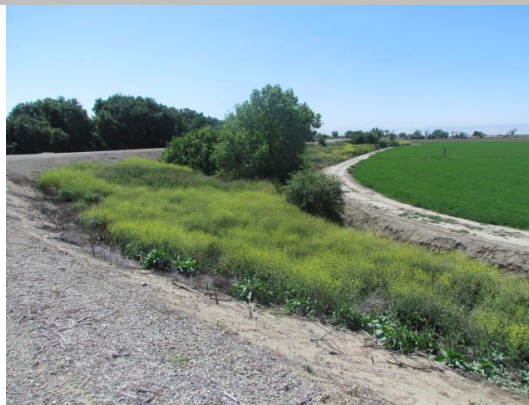
Photo 2 of 2 : SP\_2016\_RD0544\_108\_33\_20160404\_00024.jpg

LM Start	<b>4.95</b>	Rating **	A/W	Issue No.	<b>33 (cont)</b>
LM End	<b>5.26</b>	Issue Type +	Ma	Location *	LS

Looking southwest at dense vegetation at landward slope and toe.(Spring 2015)

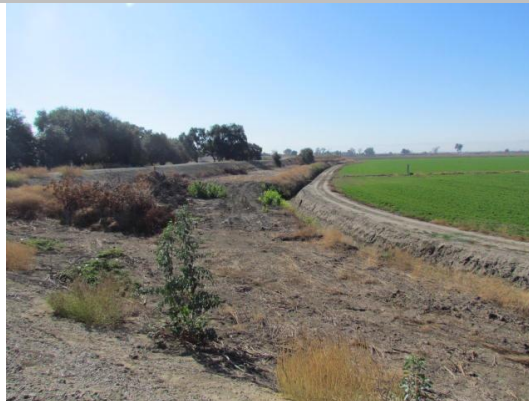
Photo 1 of 3 : SP\_2016\_RD0544\_108\_163\_20160404\_00081.jpg

LM Start	<b>4.96</b>	Rating **	A/W	Issue No.	<b>163 (cont)</b>
LM End	<b>5.01</b>	Issue Type +	En	Location *	LS

Looking southwest at ditch on landward berm fall 2015.

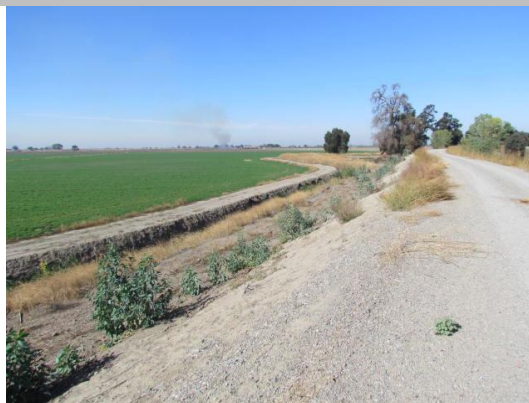
Photo 2 of 3 : SP\_2016\_RD0544\_108\_163\_20160404\_00082.jpg

Looking west at irrigation ditch on landward berm fall 2015.

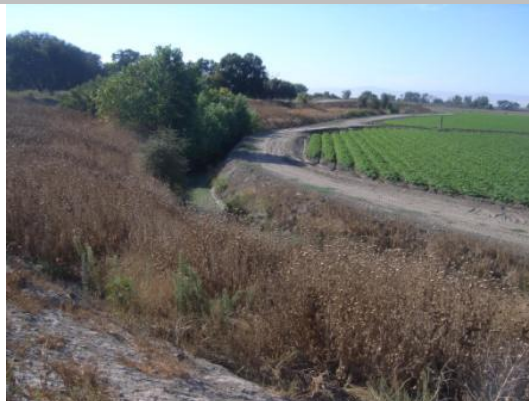
Photo 3 of 3 : SP\_2016\_RD0544\_108\_163\_20160404\_00083.jpg

LM Start	<b>4.96</b>	Rating **	A/W	Issue No.	<b>163 (cont)</b>
LM End	<b>5.01</b>	Issue Type +	En	Location *	LS

Looking southwest at ditch on landside slope and toe.

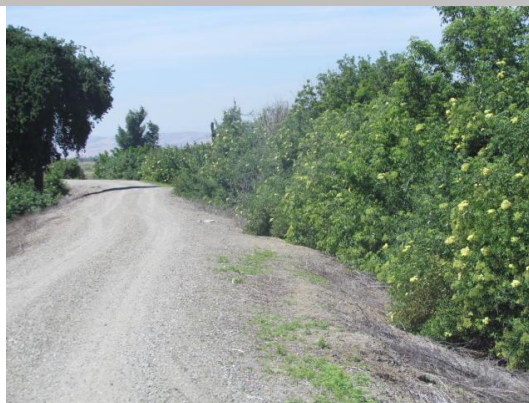
Photo 1 of 2 : SP\_2016\_RD0544\_108\_18\_20160404\_00015.jpg

LM Start	5.49	Rating **	U	Issue No.	18
LM End	5.55	Issue Type +	Ma	Location *	LS
Category	Earthen Levee			GPS Latitude/Longitude	
				Start	End
Item	Vegetation			37.812033 °	37.811687 °
				-121.319737 °	-121.320677 °
DWR ID	DWR_RD0544_01_s_2012_18				
Comment Code					
V4 : Elderberries are blocking visibility and flood fight capability.					
Inspector Comment					
Elderberry exists on the slope of the levee.

Looking south at dense vegetation on landward slope and toe.(Spring 2015)

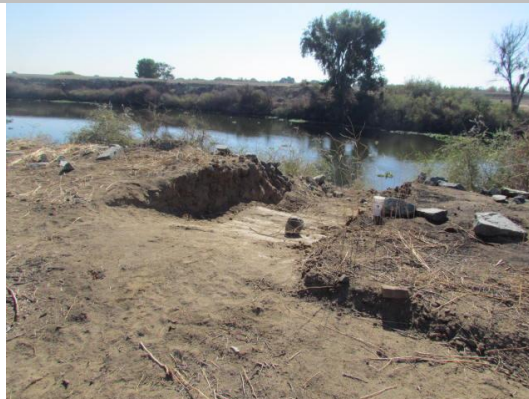
Photo 3 of 4 : SP\_2016\_RD0544\_108\_121\_20160404\_00078.jpg

LM Start	5.60	Rating **	U	Issue No.	121 (cont)	
LM End	5.60	Issue Type +	Ma	Location *	WS	
Category	Earthen Levee			GPS Latitude/Longitude		
				Start		End
Item	Erosion / Bank Caving			37.811234 °	37.811234 °	
				-121.321412 °	-121.321412 °	
DWR ID	DWR_RD0544_01_f_2015_121					
Comment Code						
E2 : Schedule repair of erosion site prior to the next inspection.						
Inspector Comment						
Someone digging/excavating on waterward berm. Excavation in 3ft wide and eighteen inches deep and ten feet long.

Looking northeast at excavation on waterward berm

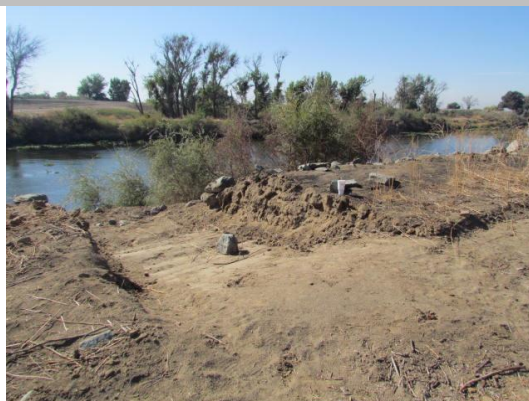
Photo 4 of 4 : SP\_2016\_RD0544\_108\_121\_20160404\_00079.jpg

LM Start	<b>5.60</b>	Rating **	U	Issue No.	<b>121 (cont)</b>
LM End	<b>5.60</b>	Issue Type +	Ma	Location *	WS

Looking southeast at excavation on waterward berm.

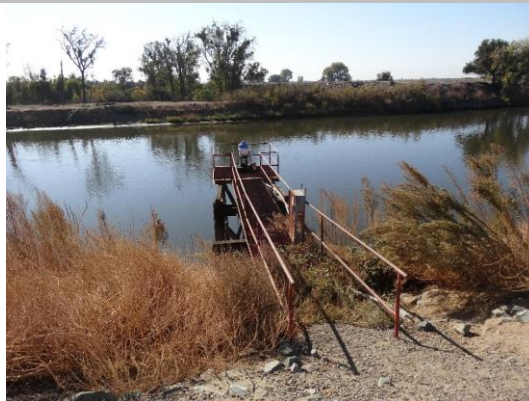
Photo 1 of 2 : UCIP\_SP\_2016\_24233\_42872.jpg

LM Start	5.71	Rating **	M	Issue No.	171
LM End	5.71	Issue Type +	En	Location *	LS
Category	Supplemental			GPS Latitude/Longitude	
				Start	End
Item	DWR UCIP Field Study			37.811193 °	37.811193 °
				-121.323532 °	-121.323532 °
DWR ID					
Comment Code					
Inspector Comment					
FS_ID:24233 DS_ID:22664 EP_NO: N/A Repair Type: Non-Urgent Crossing Status: Found UCIP Comments: - 2-inch electric conduit on waterside- service pole on landside.- needs a cover on pressure relief valve. FIELD_STRUCT_DESC: 16-inch steel pipe and electrical conduit through the levee, 5.3 feet below the crown, pump mounted on pile structure in the stream. Steel walkway to the pump. Two 36-inch concrete stand pipes on the landward side. United States Army Corps of Engineers, installation 1962. O&M Manual SJR 007, April 1964. FS Date: 10/31/2013

WS view: pump on pile structure, walkway to the pump on levee slope.

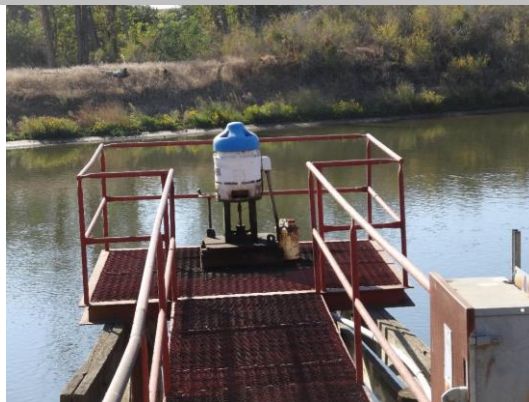
Photo 2 of 2 : UCIP\_SP\_2016\_24233\_42871.jpg

WS view: pump on pile structure in the stream. Oil leaking pump.

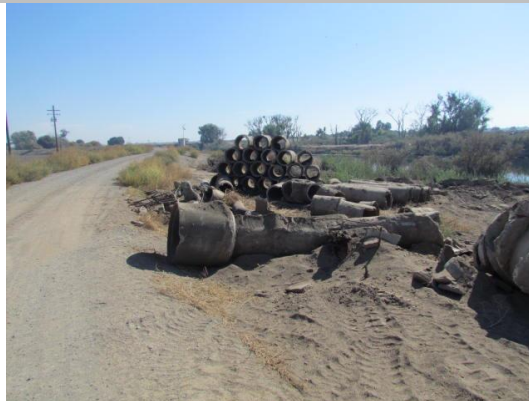
Photo 1 of 1 : SP\_2016\_RD0544\_108\_122\_20160404\_00080.jpg

LM Start	5.79	Rating **	U	Issue No.	122
LM End	5.79	Issue Type +	En	Location *	WS
Category	Earthen Levee			GPS Latitude/Longitude	
				Start	End
Item	Encroachments			37.811271 °	37.811271 °
				-121.324903 °	-121.324903 °
DWR ID	DWR_RD0544_01_f_2015_122				
Comment Code					
GA : Garbage					
Inspector Comment					
Stockpile of concrete pipes on waterward slope and berm.

Looking northeast at concrete pipes stockpiled at waterward shoulder and slope.

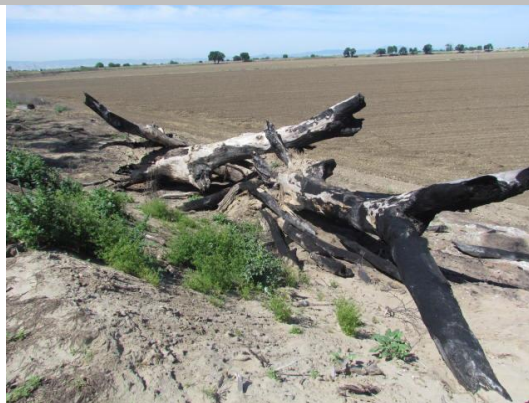
Photo 1 of 2 : SP\_2016\_RD0544\_108\_124\_20160421\_00130.jpg

LM Start	5.82	Rating **	U	Issue No.	124
LM End	5.82	Issue Type +	En	Location *	LS
Category	Earthen Levee			GPS Latitude/Longitude	
				Start	End
Item	Encroachments			37.811049 °	37.811049 °
				-121.325451 °	-121.325451 °
DWR ID	DWR_RD0544_01_s_2016_124				
Comment Code					
TR : Tree or limb					
Inspector Comment

Looking east at tree limbs on waterward slope.

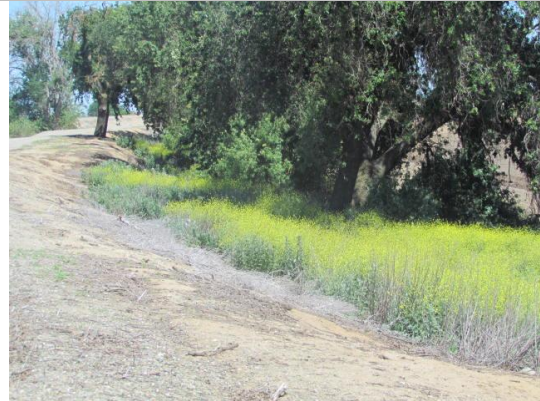
Photo 1 of 1 : SP\_2016\_RD0544\_109\_1\_20160404\_00001.jpg

LM Start	0.43	Rating **	A/W	Issue No.	1
LM End	1.12	Issue Type +	Ma	Location *	LS
Category	Earthen Levee			GPS Latitude/Longitude	
				Start	End
Item	Vegetation			37.810250 °	37.819452 °
				-121.334933 °	-121.333755 °
DWR ID	DWR_RD0544_02_s _ 2012_1				
Comment Code					
V2 : Remove the wild growth other than native grasses from the levee slopes.					
Inspector Comment

Looking southwest at dense vegetation at landward toe.

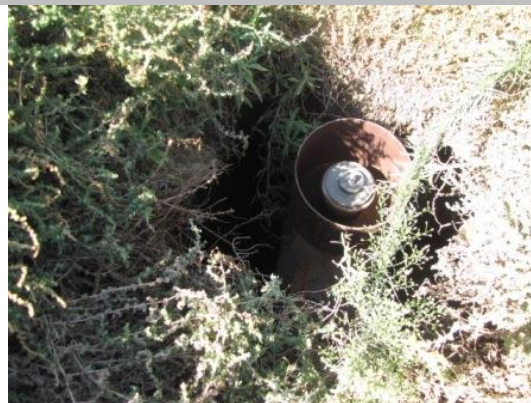
Photo 1 of 8 : SP\_2016\_RD0544\_109\_8\_20160404\_00007.jpg

LM Start	0.78	Rating **	U	Issue No.	8
LM End	0.78	Issue Type +	Ma	Location *	WS
Category	Interior Drainage & Piping Systems			GPS Latitude/Longitude	
				Start	End
Item	Erosion Areas			37.815094 °	37.815094 °
				-121.333927 °	-121.333927 °
DWR ID	DWR_RD0544_02_s_2012_8				
Comment Code					
Inspector Comment					
Caving under and around siphon on waterside shoulder. No material 3' below pipe. Caving around siphon is 20" to 24" deep approximately 72" in diameter. During 2012 spring inspection hole appears to be enlarging.

Looking at top of siphon on waterside shoulder with 3' of caving around pipe.

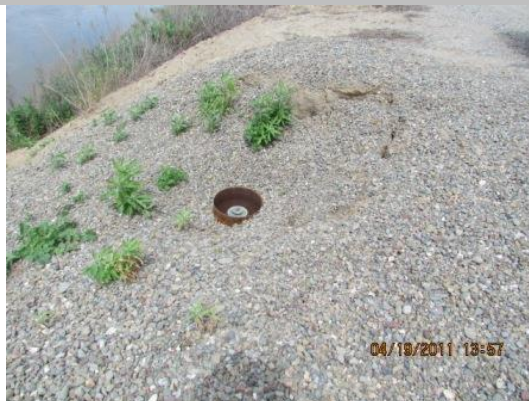
Photo 3 of 8 : SP\_2016\_RD0544\_109\_8\_20160404\_00009.jpg

LM Start	<b>0.78</b>	Rating **	U	Issue No.	<b>8 (cont)</b>
LM End	<b>0.78</b>	Issue Type +	Ma	Location *	WS

Looking south at depression greater than 6" on waterside shoulder.

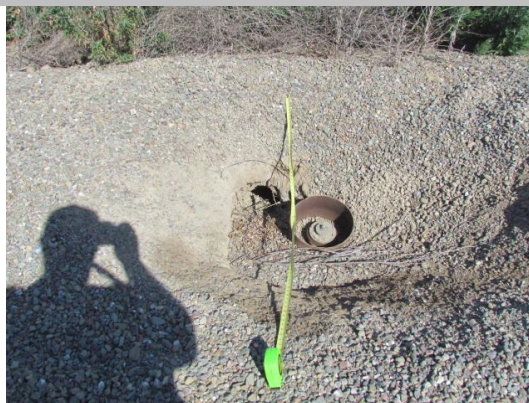
Photo 4 of 8 : SP\_2016\_RD0544\_109\_8\_20160404\_00010.jpg

Looking east at caving around siphon on waterside shoulder. (Spring 2012)

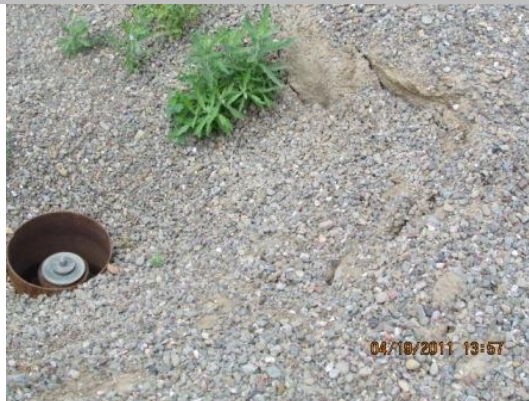
Photo 5 of 8 : SP\_2016\_RD0544\_109\_8\_20160404\_00011.jpg

Looking at top of siphon with a depression greater than 6" on waterside shoulder.

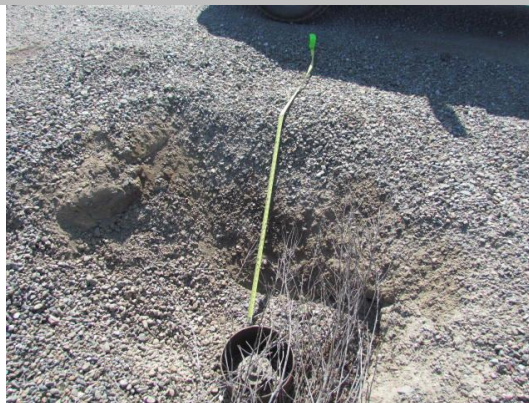
Photo 6 of 8 : SP\_2016\_RD0544\_109\_8\_20160404\_00012.jpg

LM Start	<b>0.78</b>	Rating **	U	Issue No.	<b>8 (cont)</b>
LM End	<b>0.78</b>	Issue Type +	Ma	Location *	WS

Looking west at caving around siphon on waterside shoulder. (Spring 2012)

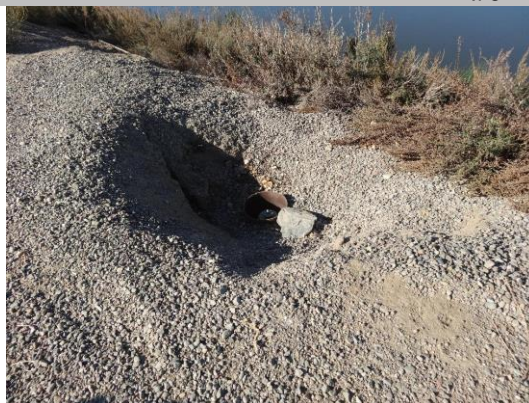
Photo 1 of 2 : UCIP\_SP\_2016\_24903\_44882.jpg

LM Start	0.78	Rating **	U	Issue No.	69
LM End	0.78	Issue Type +	En	Location *	WS
Category	Supplemental			GPS Latitude/Longitude	
				Start	End
Item	DWR UCIP Field Study			37.815098 °	37.815098 °
				-121.333903 °	-121.333903 °
DWR ID					
Comment Code					
Inspector Comment					
FS_ID:24903					
DS_ID:22665					
EP_NO: N/A					
Repair Type: Urgent					
Crossing Status: Found					
UCIP Comments: - 8 ft X 7 ft X 4 ft depression around siphon breaker on waterside slope.- no pipe visible on waterside due to dense vegetation.- electric conduit and service pole on landside.					
FIELD_STRUCT_DESC: 12-inch steel pipe through the levee, 4.0 feet below the crown. Pump in drain ditch on the landward side. Siphon breaker on waterside levee slope.					
FS Date: 10/31/2013

WS view: depression on levee slope around siphon breaker.

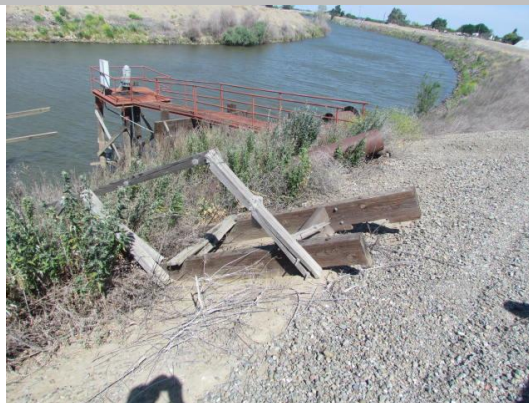
Photo 1 of 1 : SP\_2016\_RD0544\_109\_6\_20160404\_00004.jpg

LM Start	1.01	Rating **	M	Issue No.	6	
LM End	1.01	Issue Type +	En	Location *	WS	
Category	Earthen Levee			GPS Latitude/Longitude		
				Start		End
Item	Encroachments			37.818100 °		37.818100 °
				-121.332750 °		-121.332750 °
DWR ID	DWR_RD0544_02_s_2012_6					
Comment Code						
GA : Garbage						
Inspector Comment						
Discarded wooden catwalk on waterward slope.

Looking southeast at garbage on waterside shoulder and slope.

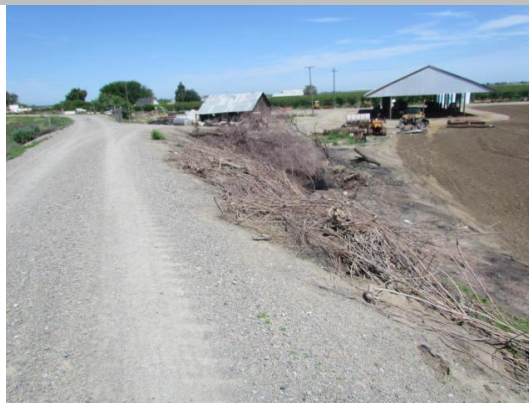
Photo 1 of 1 : SP\_2016\_RD0544\_109\_20\_20160421\_00085.jpg

LM Start	1.12	Rating **	U	Issue No.	20
LM End	1.12	Issue Type +	En	Location *	LS
Category	Earthen Levee			GPS Latitude/Longitude	
				Start	End
Item	Encroachments			37.819530 °	37.819530 °
				-121.333827 °	-121.333827 °
DWR ID	DWR_RD0544_02_s_2012_20				
Comment Code					
PR : Prunings					
Inspector Comment					
Landowner is stock piling prunings on landward slope and toe.

Looking southwest at pruning piles on landward slope.
